The Dynamic Behavior of the Basilica of San Francesco in Assisi Using Simplified Analytical Models

The Dynamic Behavior of the Basilica of San Francesco in Assisi Using Simplified Analytical Models / Arcidiacono, V.; Cimellaro, GIAN PAOLO; Piermarini, E.; Ochsendorf, J.. - In: INTERNATIONAL JOURNAL OF ARCHITECTURAL HERITAGE. - ISSN 1558-3058. - ELETTRONICO. - 10:7(2016), pp. 938-953. [10.1080/15583058.2016.1158333]

The Basilica of San Francesco in Assisi endured stronger earthquakes for centuries before 1997 earthquake, which generated the collapse of the two vaults. Experts blame as possible reasons of collapse the damage cumulated from previous earthquakes and/or the retrofitting made to the structure over its lifetime. In this paper is presented the history of the retrofit interventions of the Basilica through the centuries, focusing mainly on the roof, which has been subjected to three major restorations through its life. It is shown using simple analytical models that the cumulative effects of the changes made to the roof of the Basilica affected the structure's dynamic behavior in a negative manner, increasing the seismic loads on the existing structural members. In particu

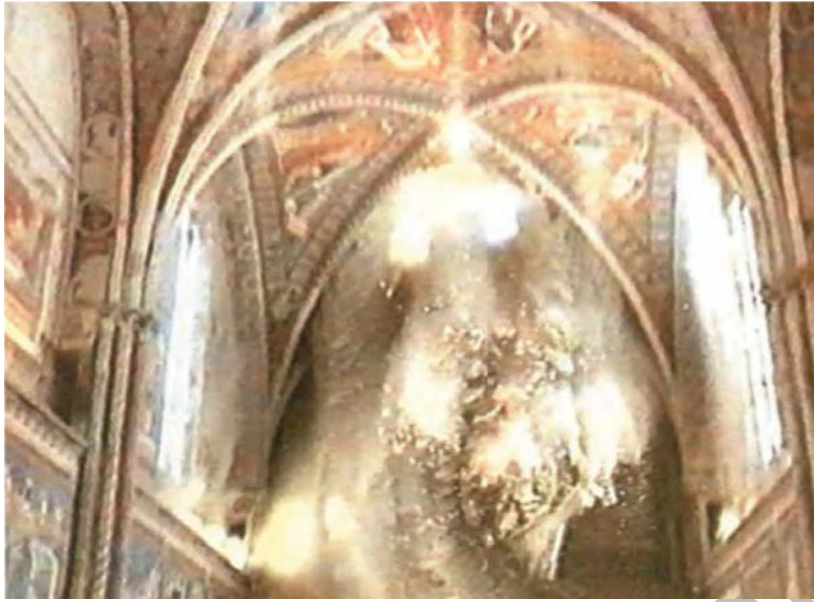
Figure 4- Collapse of the vault of the Doctors of the Church (Bonsanti, 1998).

The next morning at about 11:42 AM, a second tremor of magnitude 5.8 hit the Basilica. This time, Roli was just outside the doors of the Basilica and a camera crew from Umbria TV was at the front of the nave videotaping. Roli reports that “the jambs of the Basilica's doors rose, then fell while \lurching first forward then back...”. As seen in Figure 4, Umbria TV cameramen were

able to capture the collapse of the easternmost quadrant of the Gothic vault adjacent to the facade, which fell on individuals fleeing for the door and resulted in 4 deaths (Bonsanti, 1998). In addition to the vaults collapsing near the facade, those adjacent to the triumphal arch also collapsed.

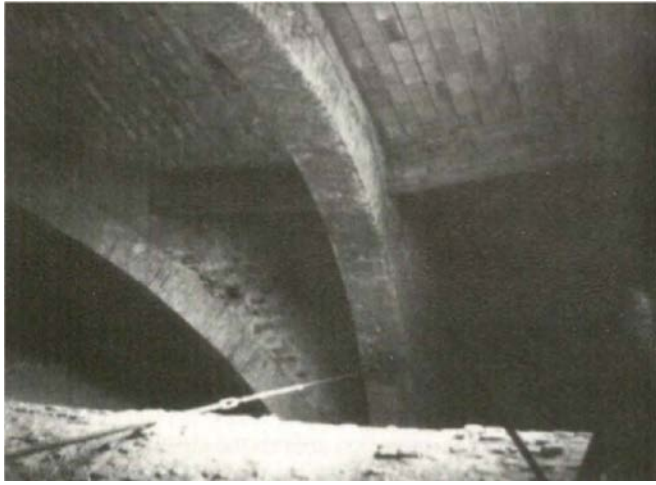
Figure 7- Tie installed during the 1958 (Rocchi, 2002).
